**RECLAMATION DISTRICT NO. 1608
LINCOLN VILLAGE WEST
BOARD OF TRUSTEES MEETING
WEDNESDAY, JUNE 5, 2019
8:00 A.M.
ENGINEER'S REPORT**

EXHIBIT A: Violation/Remedy Tracking for 2019 Inspection

EXHIBIT B: Before and After Photos of compliant vegetation clearing at 6249 Embarcadero Drive the Fisher residence

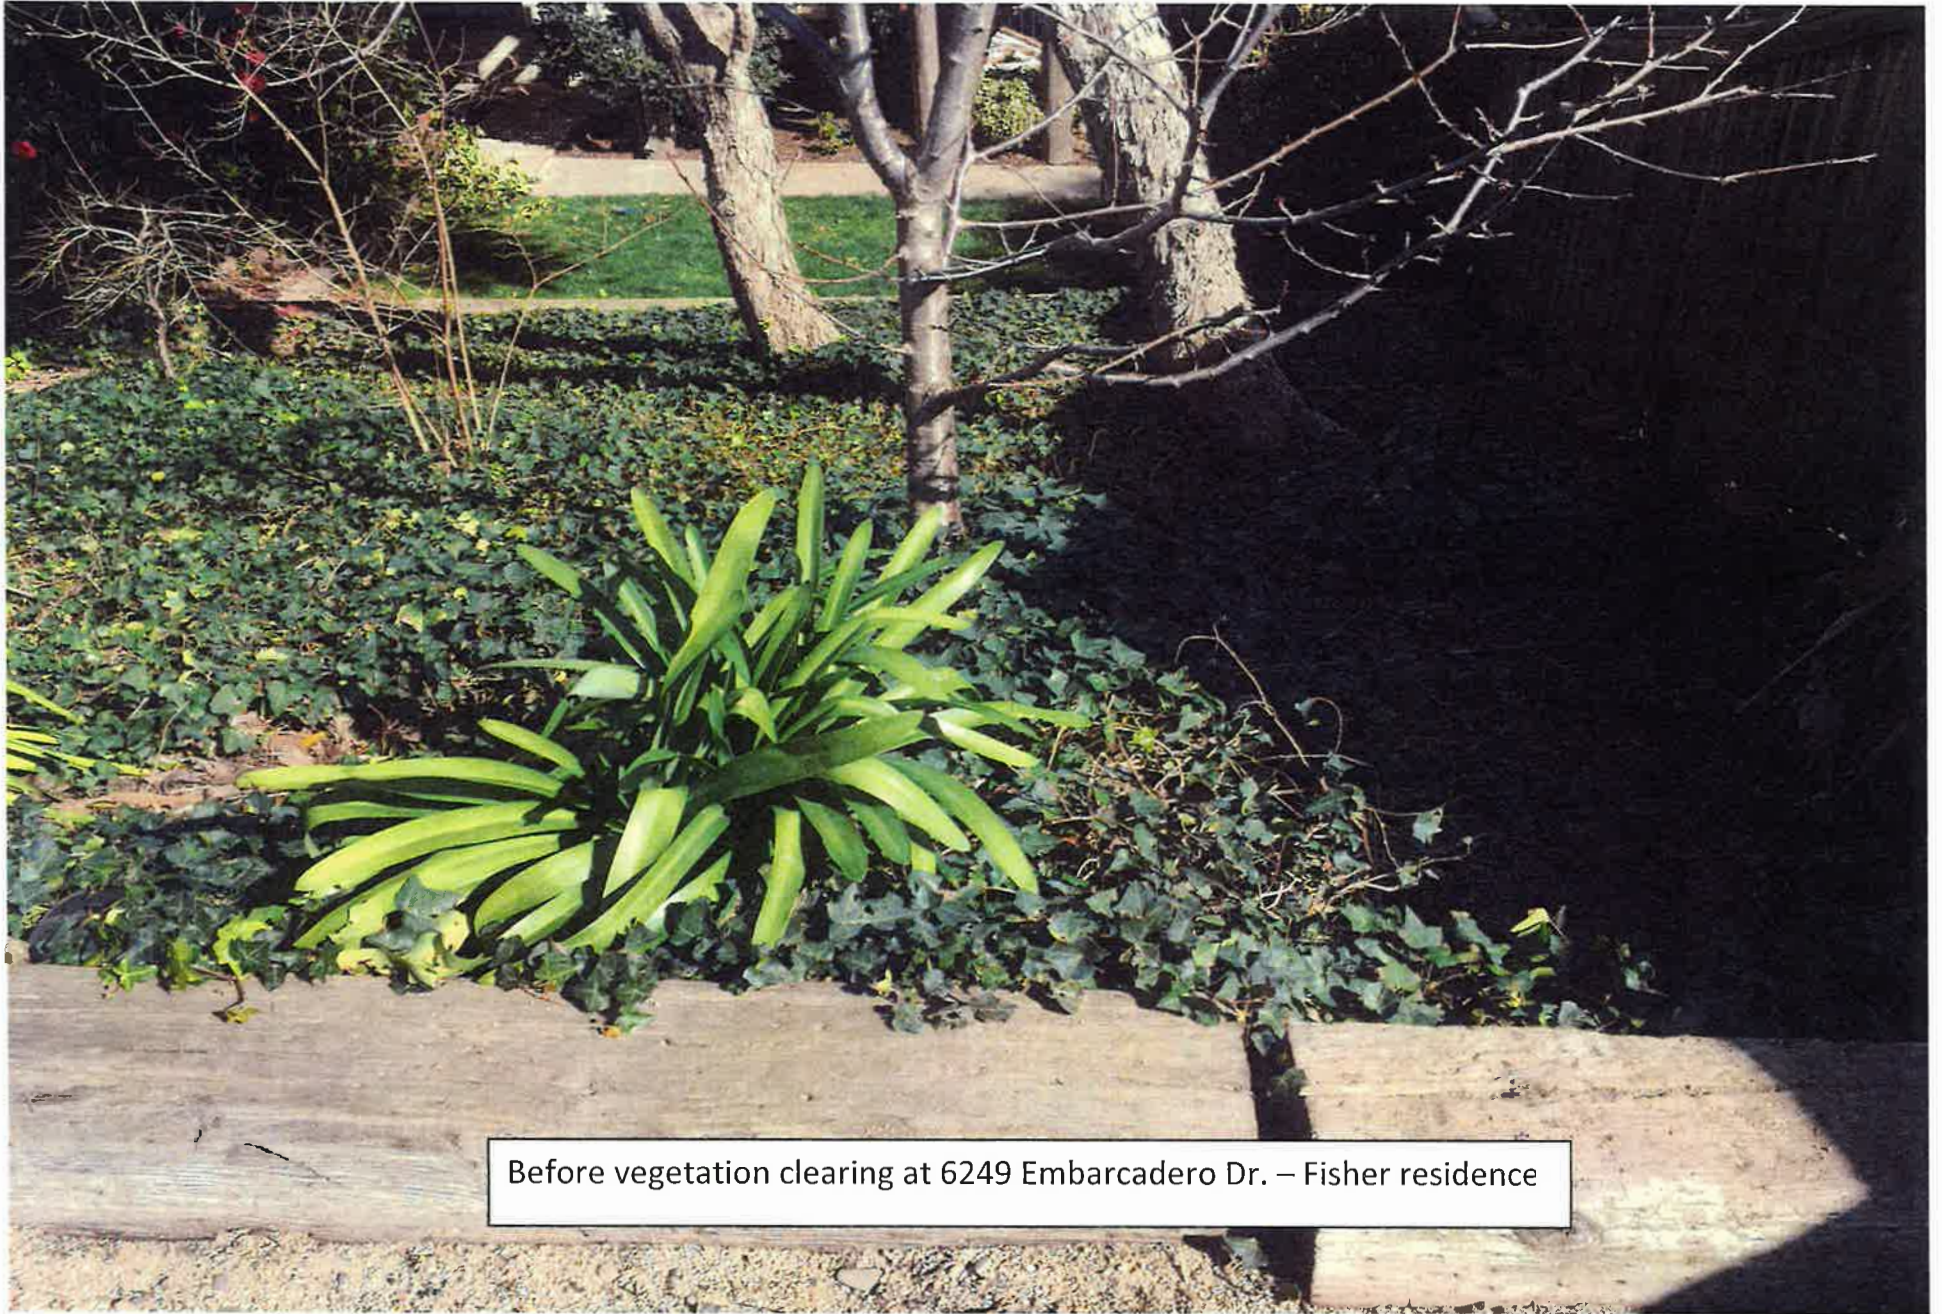
NOTES:
 Vegetation clearing required on landside levee slope, as it is too dense to see any underlying slope. An example of how to trim is in the homeowner's violation letter package for 2019.

Before vegetation clearing at 6249 Embarcadero Dr. – Fisher Residence

Before vegetation clearing at 6249 Embarcadero Dr. – Fisher residence

5/23/19 WLF spoke with Joe Bryson and he inspected vegetations clearing of Fisher's property and it was in compliance. AJL added follow-up photo's of vegetation clearing to Fisher's file.

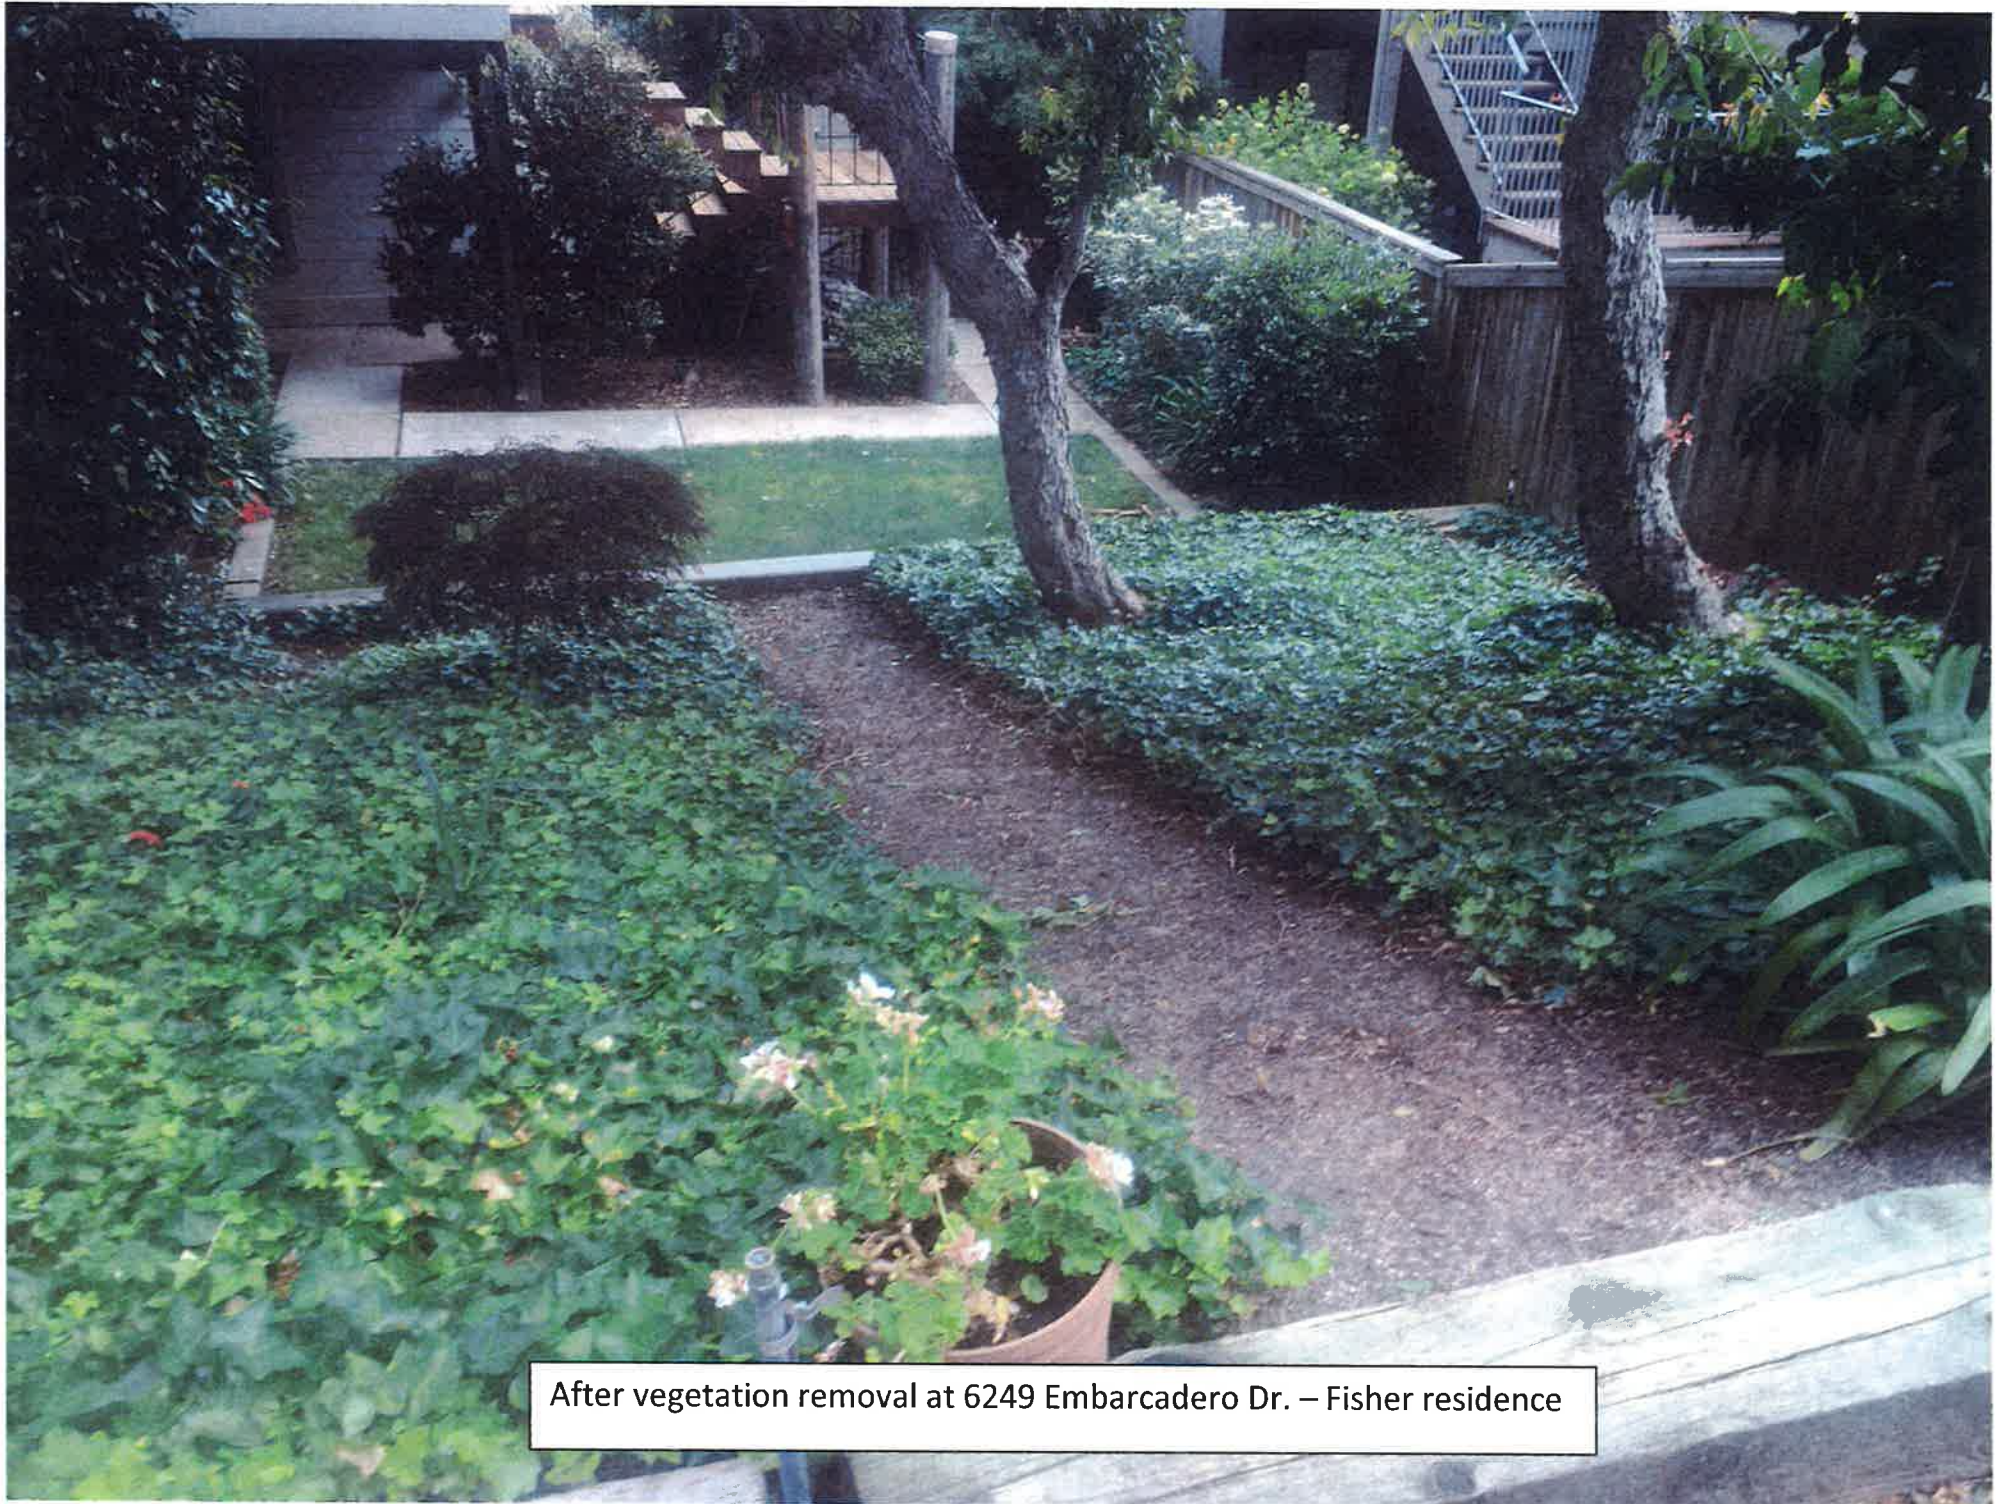
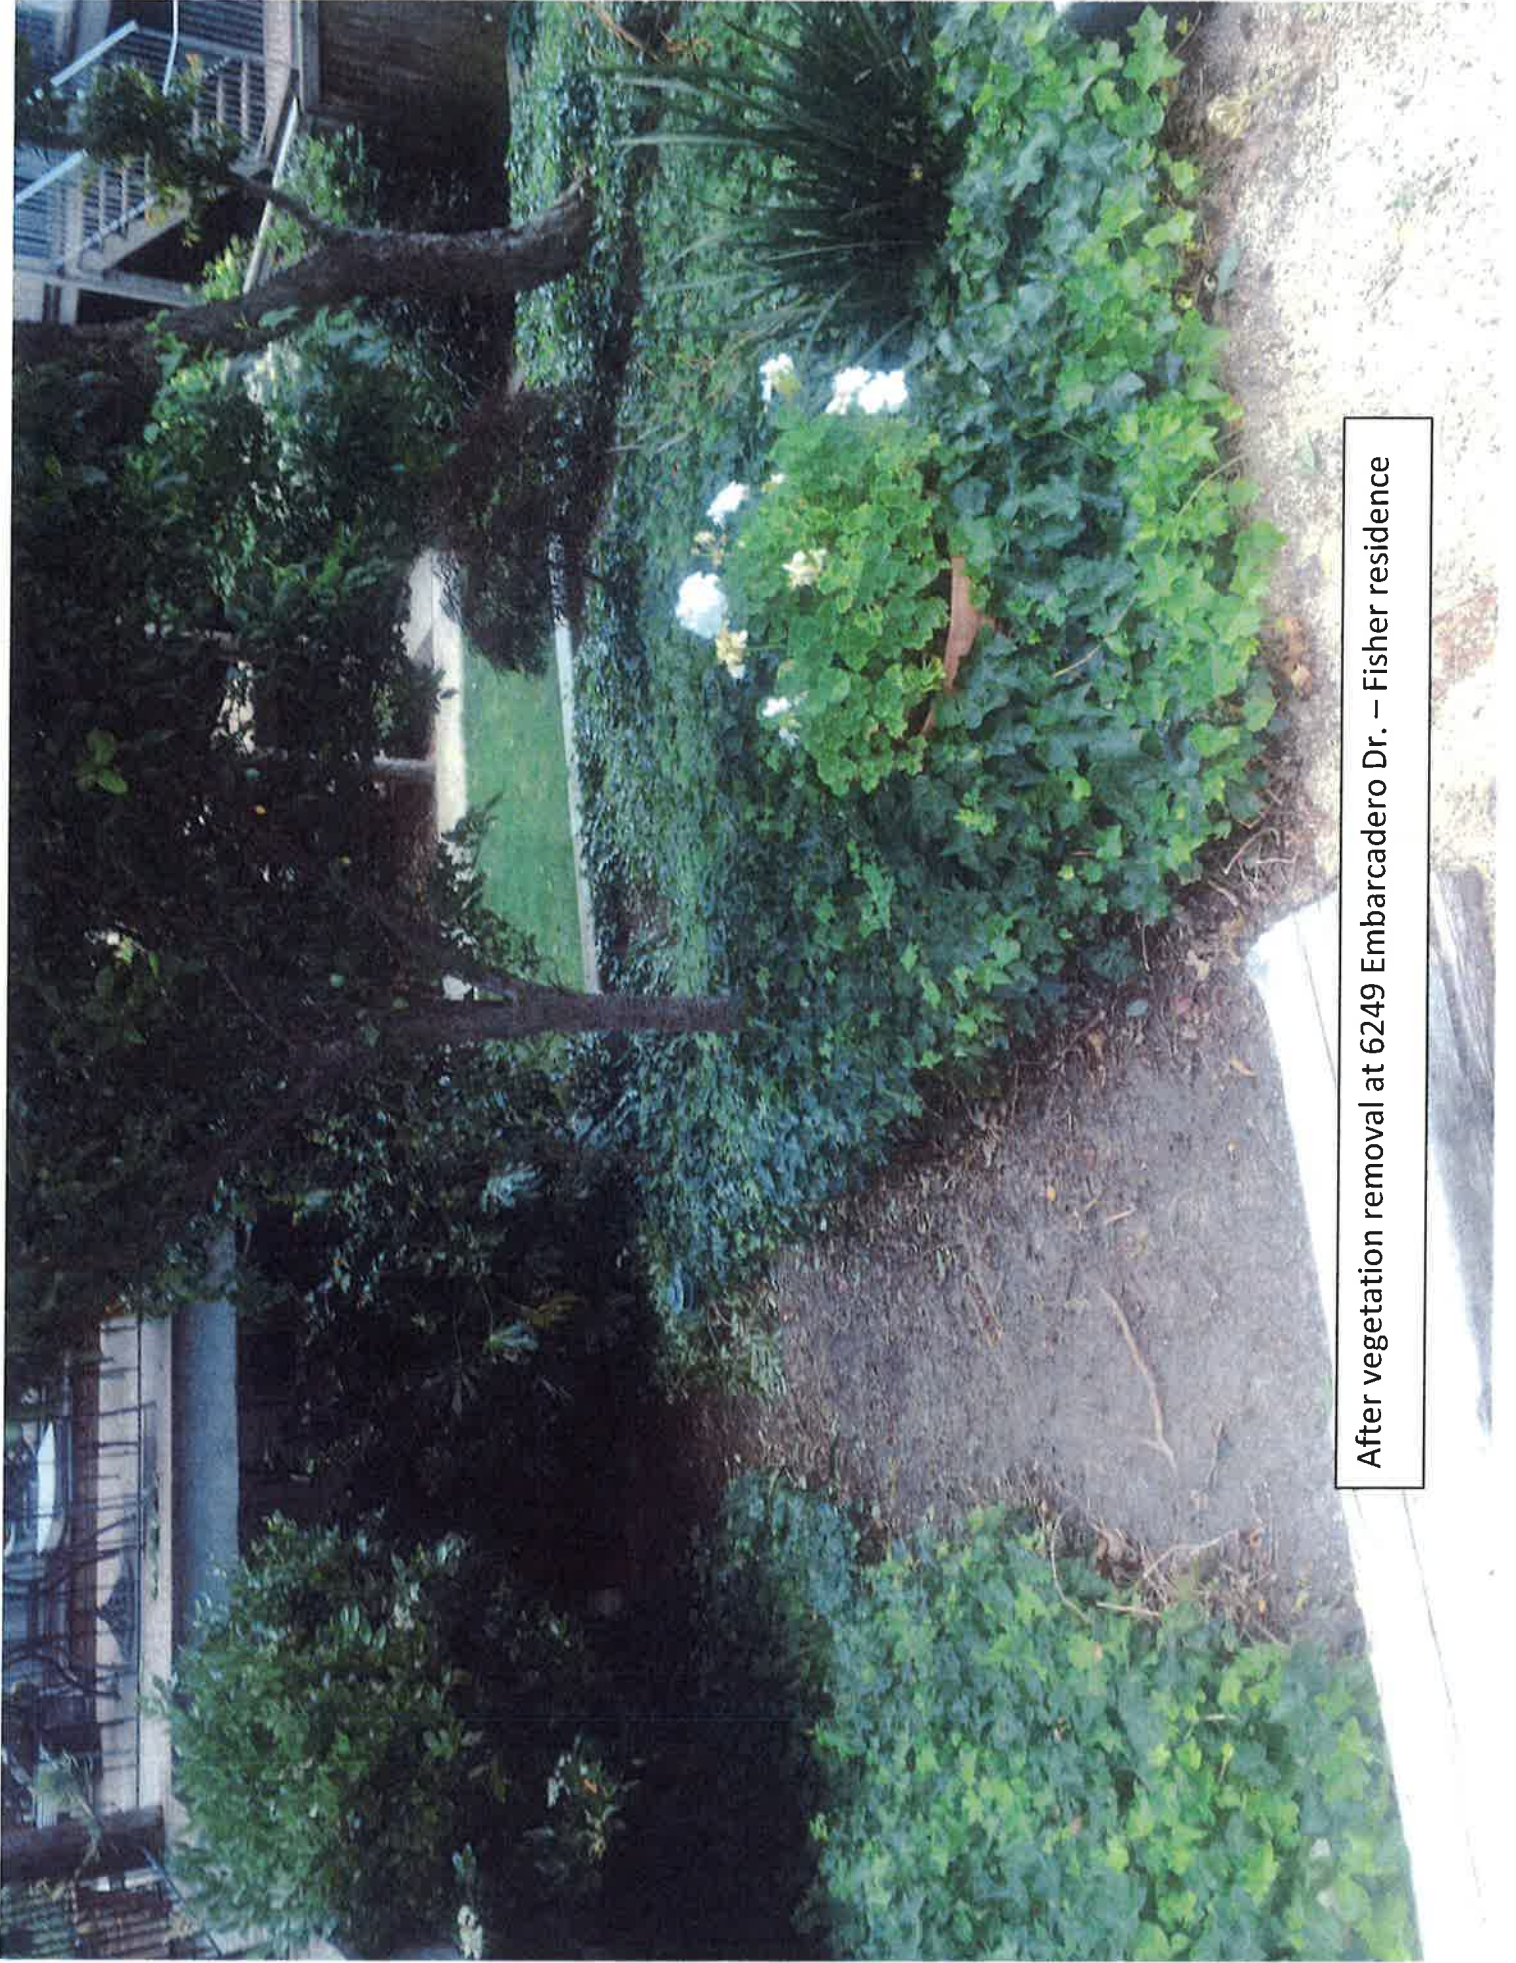
After vegetation removal at 6249 Embarcadero Dr. – Fisher residence

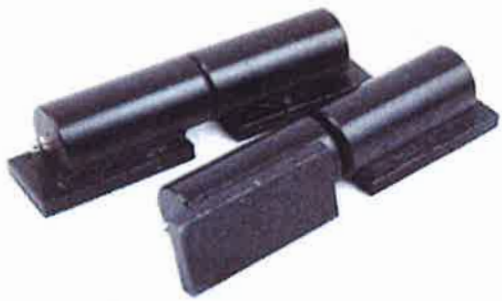
**New Heavy Duty Gate Hinge Pair -
7" Barrel Style 900lb Capacity -
Weld On Install**

ACTIVITY	QTY	RATE	AMOUNT
Levee work Cut out and remove old J bolt hinges, install 4 new 5" or 7" heavy duty weld on barrel hinges (two per gate side). Remove old gate latch and install new weld on heavy duty flip gate latch. Remove old drop rod and weld 3/4"x 1' pipe sleeve for new heavy duty 5/8" x 36" drop rod (one per gate side) drill hole's in concrete in levee crown and put 3/4"x 6" pipe sleeve for drop rod keeper. Repair work is for the southwest levee crown dual swing gates and work will be done with one welder/welding truck and one laborer. Price is per crew hour and per dual swing gates (welder/welding truck and one laborer only. Parts and supplies are a separate cost listed below)	4	295.00	1,180.00
Materials 5/8"x 36" heavy duty drop rod (price is per drop rod)	1	17.00	17.00
Materials Pair of 5" heavy duty weldable barrel hinges with grease zerk (450 pound capacity)	1	27.00	27.00
Materials Pair of 7" heavy duty weldable barrel hinges with grease zerk (900 pound capacity)	1	36.00	36.00

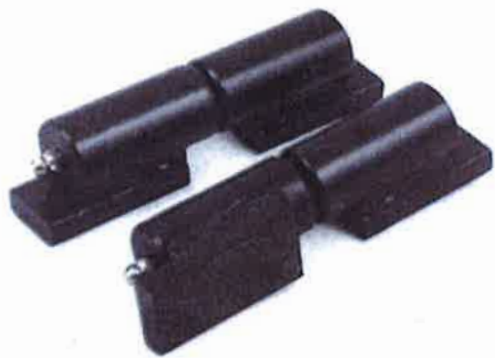
Heavy Duty Weldable Gate Hinge
Pair - 5" Barrel Style 450lb
Capacity

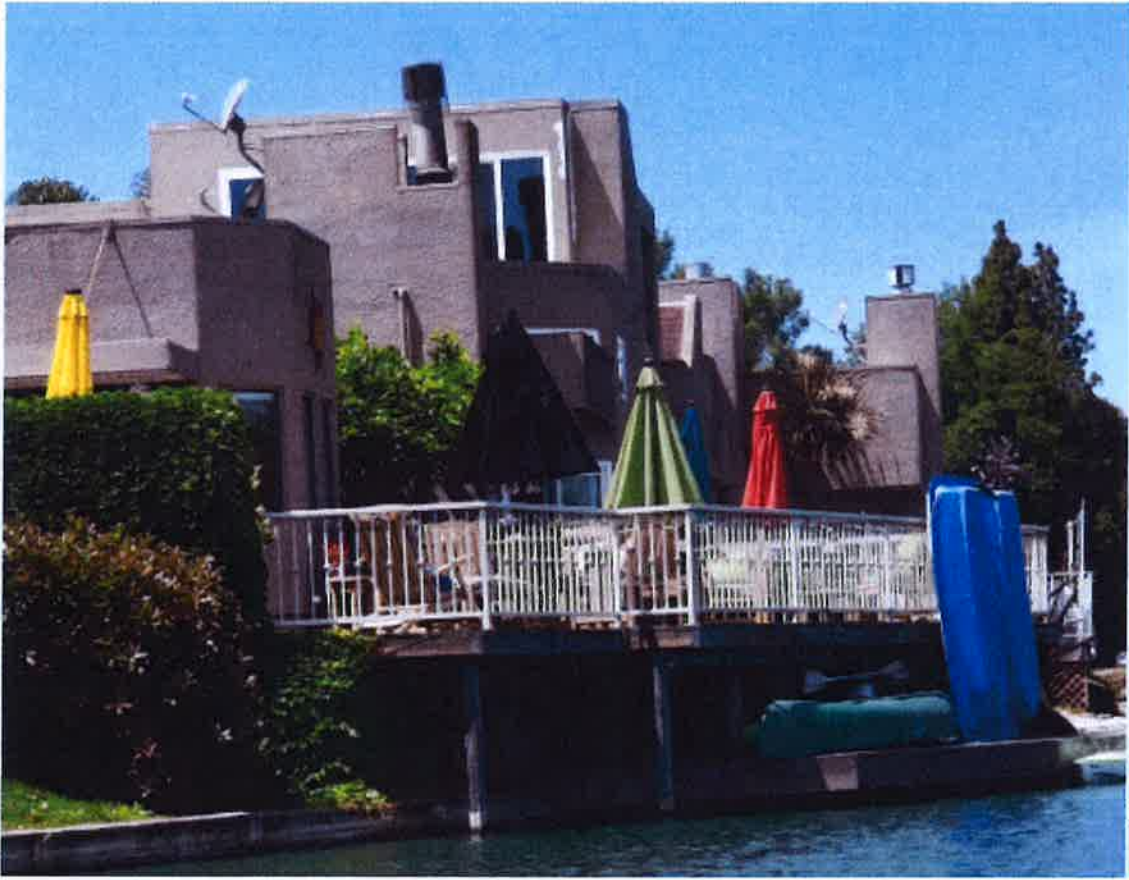
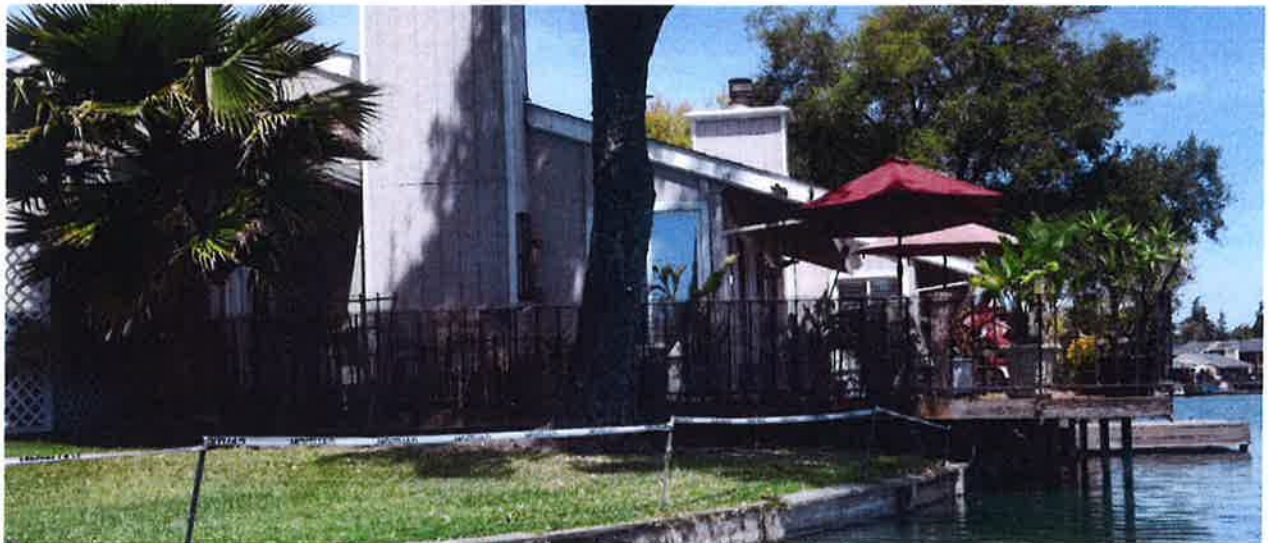
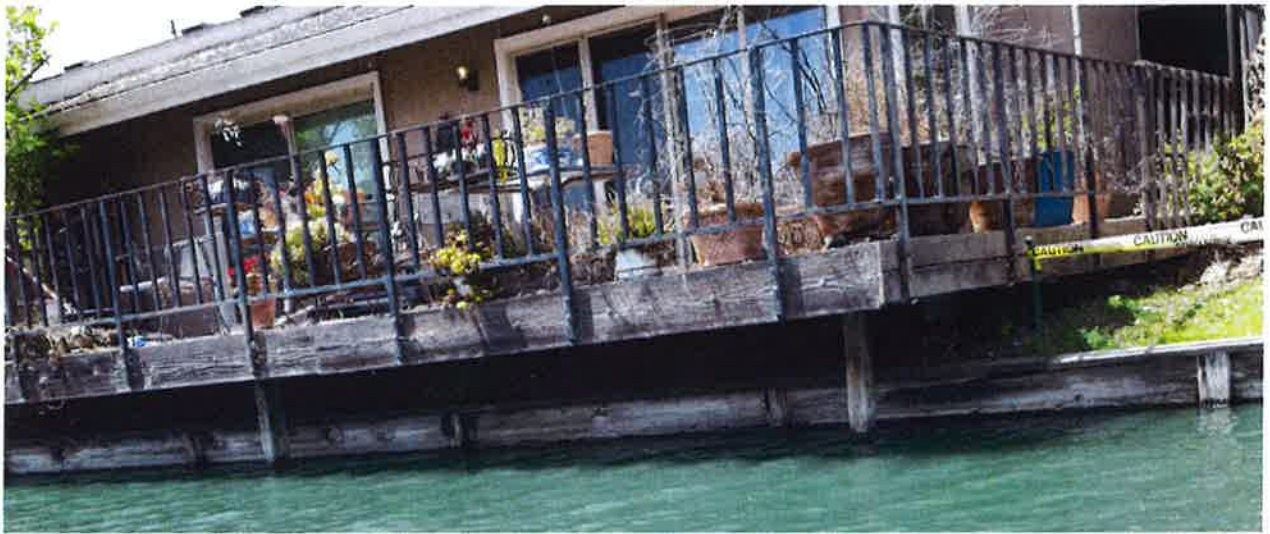
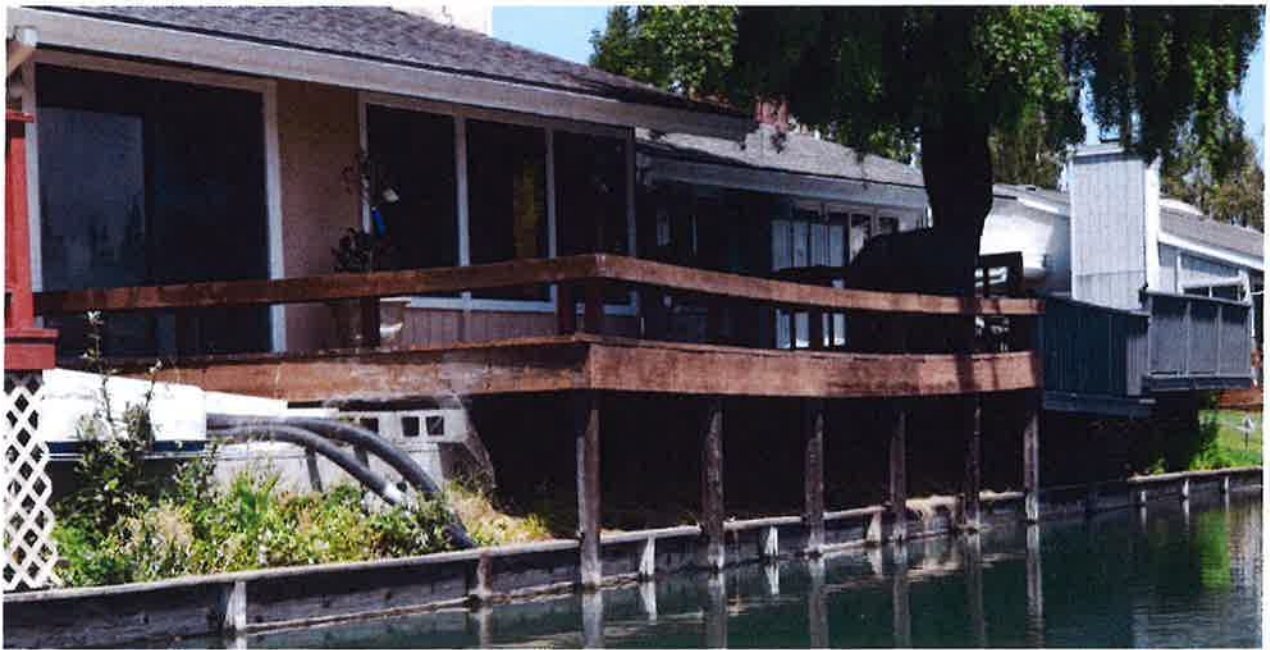
Category III Decks

- III. **Category III** consists of structures containing an element that is: 1) Attached to the structure; 2) extends over the SFHA; and 3) Is supported by pier extending directly into the SFHA.

Category III structures are non-compliant and will not receive an out of the SFHA Determination in their current state of construction. There are a number of solutions that will allow a favorable determination however **they will require modification to the element**. Category III elements are predominately found in condominium lots.

Category III solutions are presented in no specific order of preference. Solutions A – C will lead to favorable determination however it is highly dependent on the resident's willingness to modify existing elements.

- A. Detached element: Detaching the supports from the structure and installing a new foundation supports such that the deck is self-supporting and provides the separation required. Under this solution, the piers can remain in place. By certifying that the deck is detached, a determination should follow suit.

- B. Reconfigured the Water Side Supports: The resident must install new supports on high ground leaving a cantilevered section or installing angled supports along the cantilevered section. The pier support must be removed so that only high ground supports are touching the element.

- C. Remove these properties from the Determination: We can adjust the Mets and Bounds description such that we remove a specific property from the determination. Under this alternative only compliant structures will be mapped out of the SFHA.
