**RECLAMATION DISTRICT NO. 1608
LINCOLN VILLAGE WEST
BOARD OF TRUSTEES MEETING
WEDNESDAY, JULY 3, 2019
8:00 A.M.
ENGINEER'S REPORT**

EXHIBIT A: Violation/Remedy Tracking for 2019 Inspection

Lincoln Village West Violation/Remedy Tracking 2019

**Re: Reclamation District No. 1608 – Lincoln Village West District, Year-Round
Levee Encroachments and Vegetation Maintenance Requirements REMINDER
in order for Homeowners along the Districts levees to Avoid Violations of Levee
Encroachment Standards**

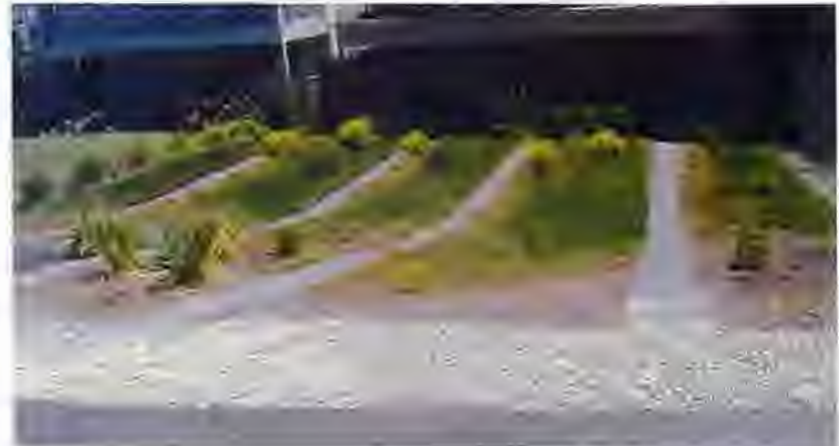
SAMPLE

1. TREES TRIMMED MINIMUM 5 FEET FROM GROUND EVERYWHERE.
2. SHRUBS TRIMMED MINIMUM 2 FEET FROM GROUND EVERYWHERE.
3. SHRUBS LESS THAN 2 FEET TALL PROVIDE HORIZONTAL GAPS OF 2 FT IN WIDTH EVERY 15 FEET TO ALLOW VISUAL INSPECTION.
4. FENCE: SEE THROUGH (i.e. CHAIN LINK, WOODEN SLATS EVERY OTHER, ETC.)

Before
Vegetation Clearing

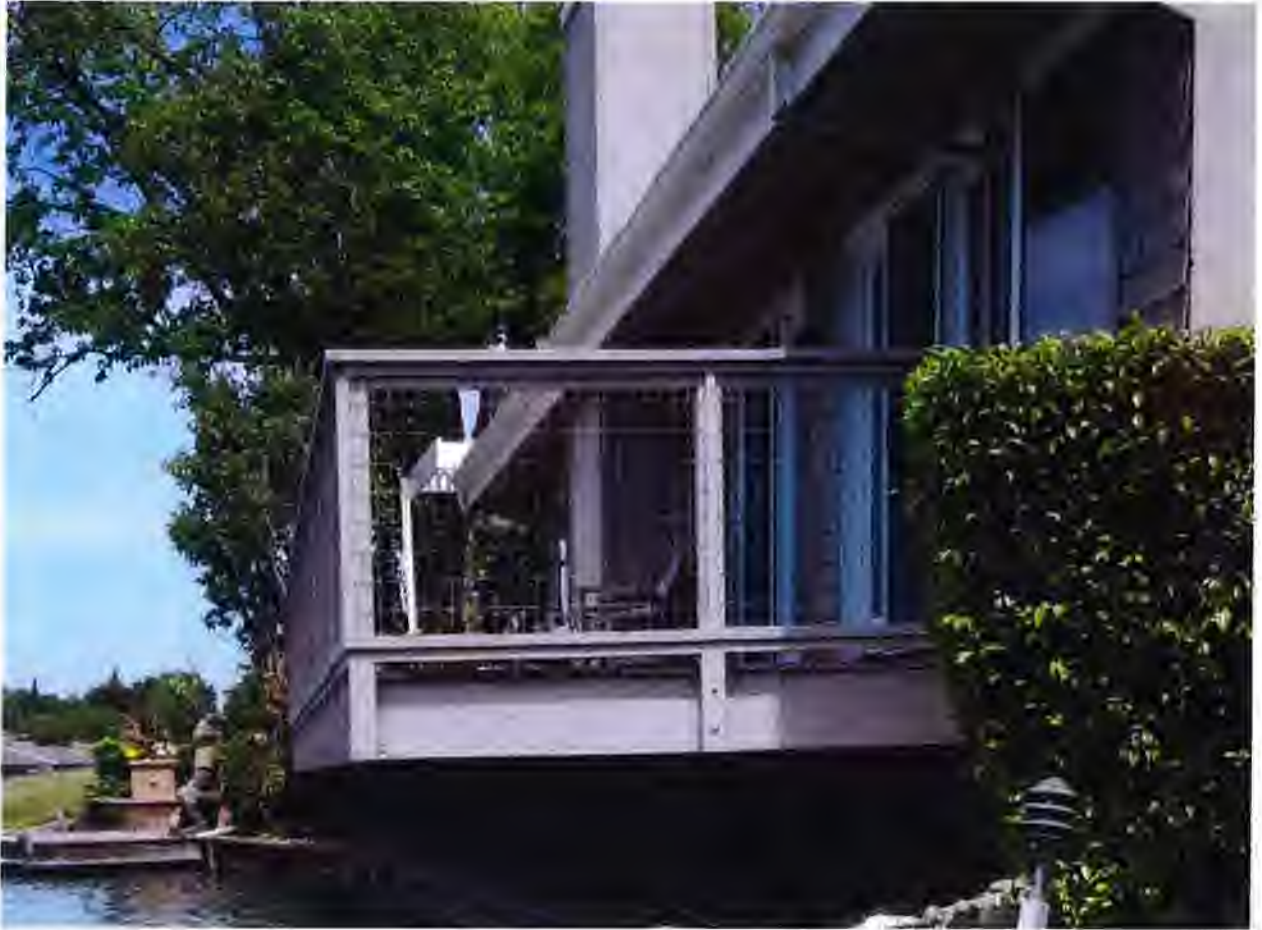
Category I Deck

- I. **Category I** consists of structure whose elements were attached to the structure however do not extend beyond the lake bulkhead.
 - There are a total of 4 structures within this category and were eliminated from the review as the properties contained elements that ended behind the lake bulk head and did not extend over to the Lake.

- Category I structures do not require additional qualifying and should reach an “out of the Special Flood Hazard Area (SFHA)” determination without issue.

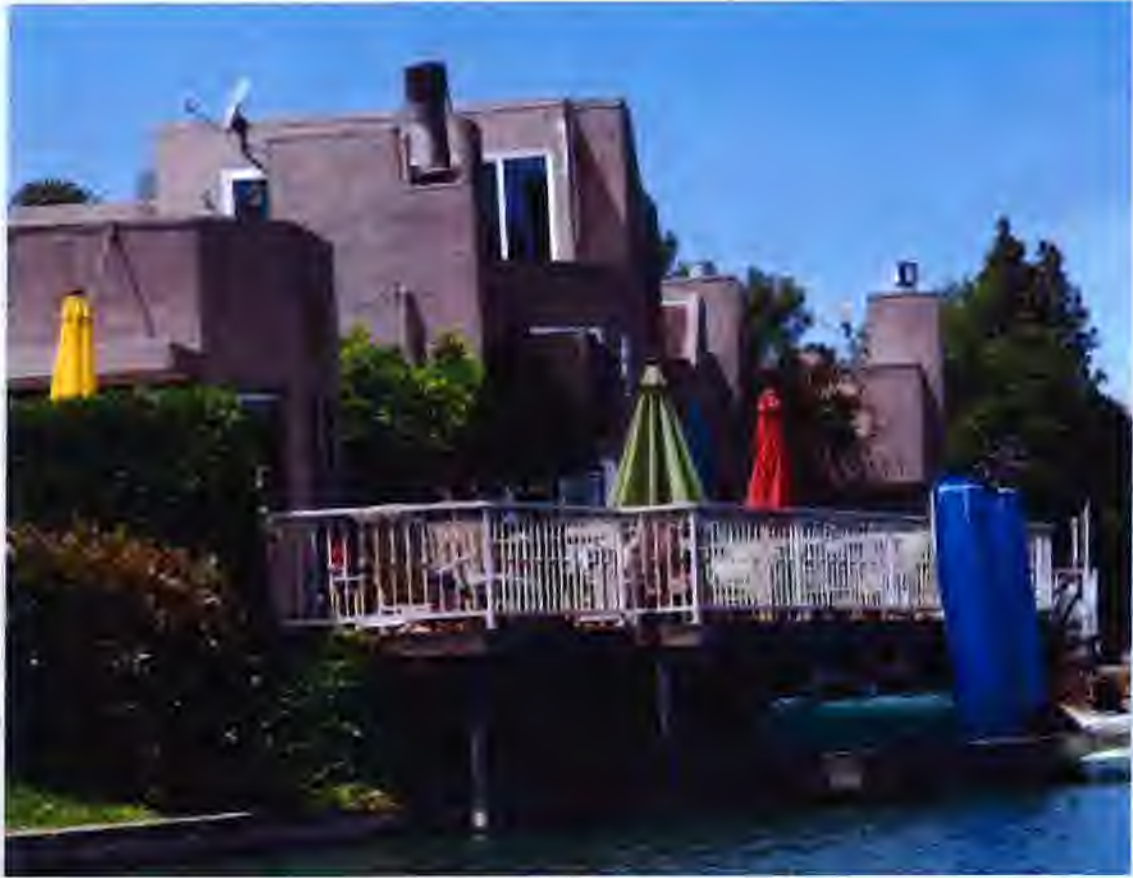
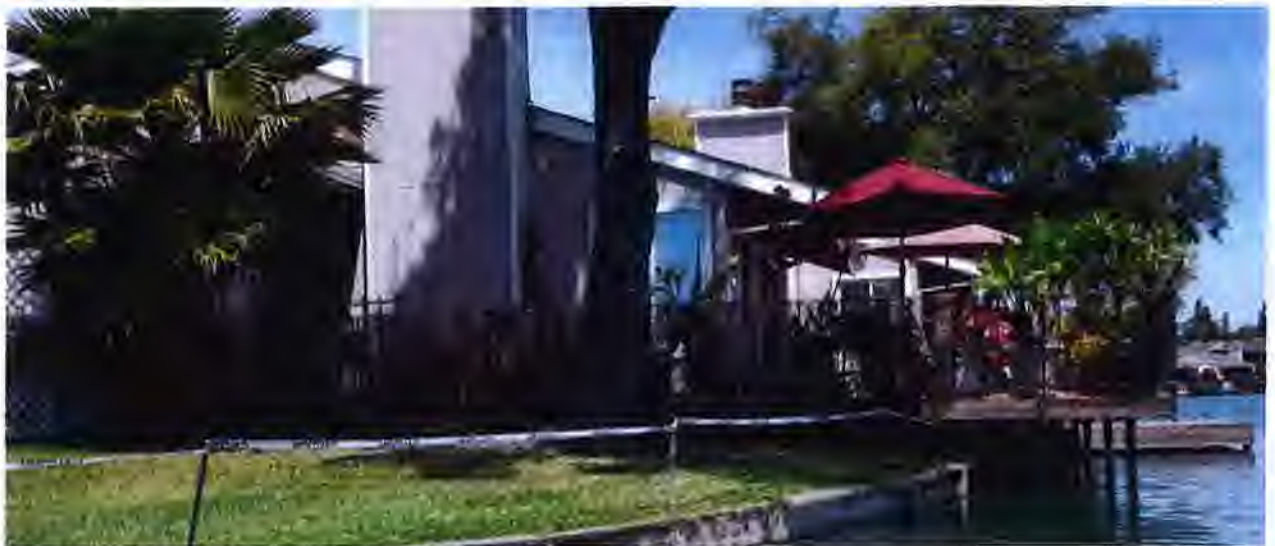
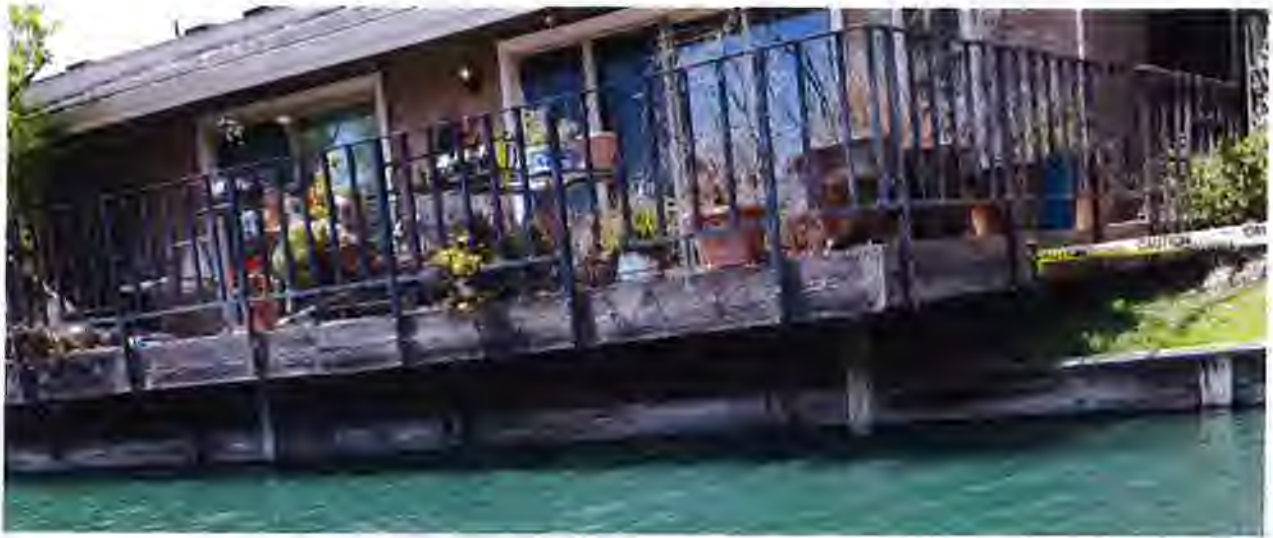
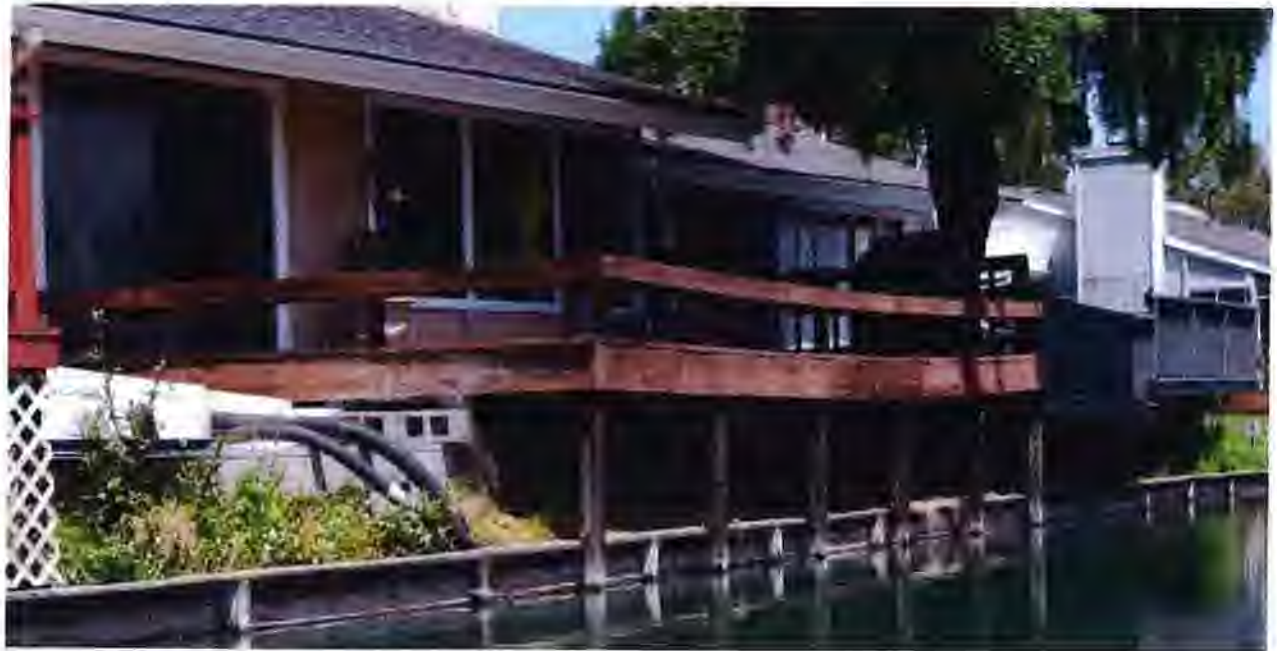
Category III Decks

- III. **Category III** consists of structures containing an element that is: 1) Attached to the structure; 2) extends over the SFHA; and 3) Is supported by pier extending directly into the SFHA.

- There are 12 structures that meet this description.

Category III structures are non-compliant and will not receive an out of the SFHA Determination in their current state of construction. There are a number of solutions that will allow a favorable determination however **they will require modification to the element**. Category III elements are predominately found in condominium lots.

Category III solutions are presented in no specific order of preference. Solutions A – C will lead to favorable determination however it is highly dependent on the resident's willingness to modify existing elements.

- A. Detached element: Detaching the supports from the structure and installing a new foundation supports such that the deck is self-supporting and provides the separation required. Under this solution, the piers can remain in place. By certifying that the deck is detached, a determination should follow suit.

- B. Reconfigured the Water Side Supports: The resident must install new supports on high ground leaving a cantilevered section or installing angled supports along the cantilevered section. The pier support must be removed so that only high ground supports are touching the element.

- C. Remove these properties from the Determination: We can adjust the Mets and Bounds description such that we remove a specific property from the determination. Under this alternative only compliant structures will be mapped out of the SFHA.
